EUROPEAN PATENT APPLICATION

(71) Applicant: **UNITED TECHNOLOGIES
CORPORATION**
Hartford, CT 06101 (US)

(54) **Method for repairing an apertured gas turbine component**

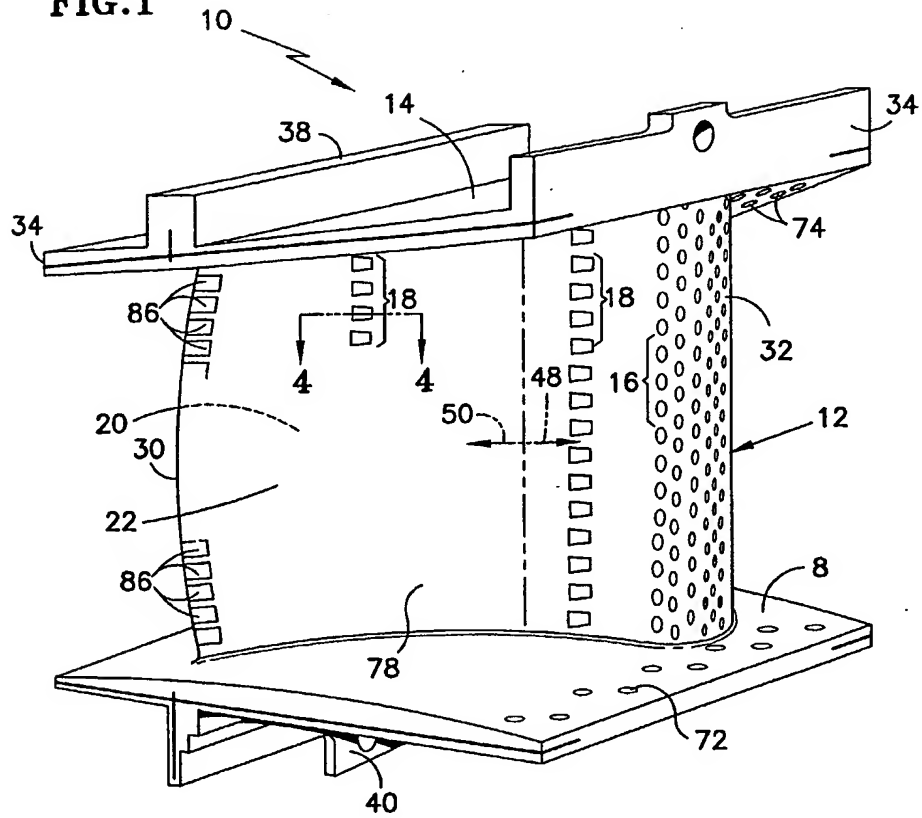
FIG.1

Fig. 1 is a perspective view of a typical gas turbine engine high pressure turbine vane;

[0025] Referring to Fig. 1, a high pressure turbine vane (article) 10 is shown. Referring also to Figs. 2 and 3, a top view and a bottom view are respectively shown for the vane 10 of Fig. 1. The vane 10 comprises an airfoil section (airfoil) 12 having at least one internal cavity 24 (Fig. 2), the internal cavity 24 having an internal surface 26 (Fig. 2). The airfoil section 12 has a convex surface 20 and a concave surface 22. The convex and concave surfaces 20, 22, respectively, are bounded by a trailing edge 30 and a leading edge 32 and together form an exterior surface 78 of the airfoil. The exterior surface 78 is exposed to the hot gas path. The trailing edge 30 of the airfoil 12 includes cooling slots 86. Also, the airfoil section 12 is bounded by an inner diameter platform (platform) 8 and an outer diameter platform (platform) 14. The inner and outer diameter platforms 8, 14 create the gas path annulus and include cooling holes 72, 74, respectively. The outer diameter platform 14 includes opposing flanges 34, at least one cover 36 (Fig. 2), preferably two, and a rail 38. The inner diameter platform 8 includes a rail 40 and a cover 42 (Fig. 3), preferably two.

[0027] The vane 10 lies in the hot gas path and the vane 10 is air-cooled by flowing cooling air, typically from the compressor discharge, into the internal cavities 24. Cooling air enters the internal cavities 24 through corresponding openings in the platforms 8, 14. This air cools the internal surface 26 of the airfoil 12 by convection or internal baffle impingement and cools the convex and concave surfaces 20, 22, respectively, of the airfoil 12 by film cooling. The air is directed from the internal cavities 24 and outward across the vane 10 by a plurality of cooling holes, preferably cylindrical cooling holes 16 and diffusion cooling holes (diffusion holes) 18, to help it withstand the high temperatures to which it is exposed. The cooling air is also directed across the platforms 8, 14 upon exiting the respective cooling holes 72, 74. The trailing edge 30 is cooled by air exiting through the slots 86.

[0028] Although Fig. 1 shows the plurality of cooling holes 16, 18 located on the concave surface 22, it is readily understood by those skilled in the art that the plurality of cooling holes 16, 18 are formed on both the convex and concave surfaces 20, 22, respectively.

[0031] Referring now to Figs. 1 and 4, it is noted that the vane 10 has a plurality of diffusion holes 18 which may have various geometries and predetermined air flow characteristics based on location within the vane 10. The representative diffusion hole 18, shown in Fig. 4, has a metering passage 60 in fluid communication with a diffusion passage (mouth) 52, each having a predetermined geometry. The metering passage 60 has an inlet 76 with a predetermined throat area, shown as A_t , where the throat area A_t provides a predetermined air flow requirement. Thus, the inlet 76 regulates cooling air flow into the diffusion holes 18 from the internal cavities 24. The diffusion passage 52 is axially diverging, nonregulatory and extends from the inlet 76 to an outlet 77 at the exterior surface 78 of the vane 10. The diffusion passage 52 facilitates the film cooling of the exterior surface 78 of the airfoil 12 as the cooling air exits from the diffusion passage 52 of the diffusion hole 18. The diffusion passage 52 also includes an inner shaped portion (inner diffuser portion) 80 while the metering passage 60 includes an inner metering portion 82.

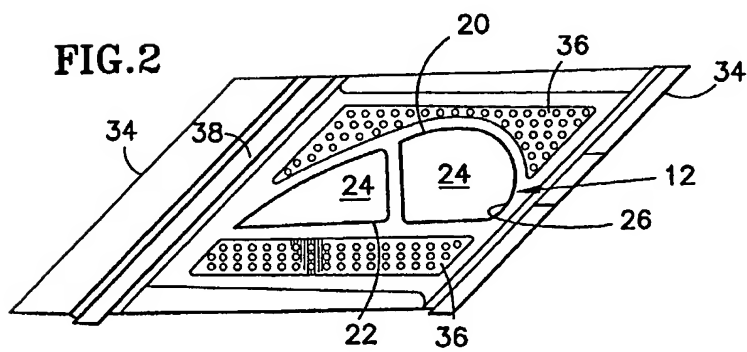
FIG.2

Fig. 2 is a top view of the vane of Fig. 1;

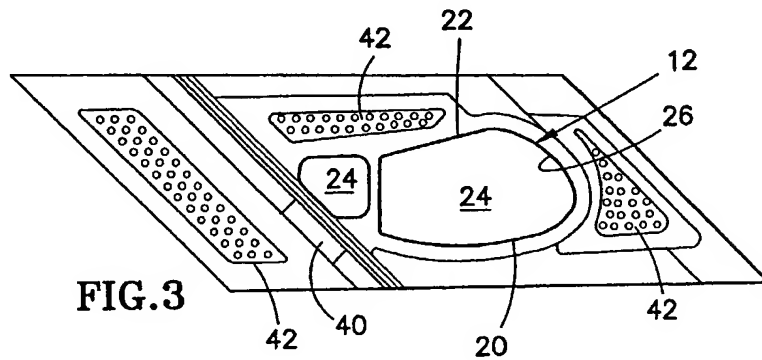
FIG.3

Fig. 3 is a bottom view of the vane of Fig. 1;

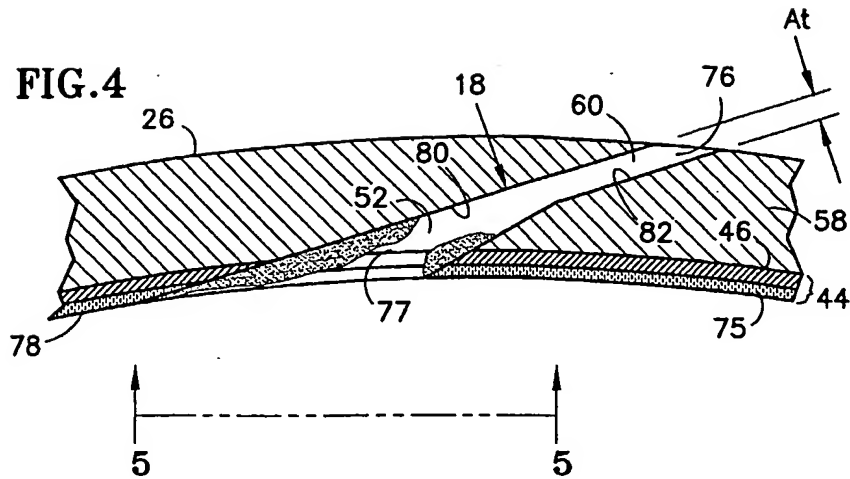
FIG.4

Fig. 4 is an enlarged cross-sectional view taken essentially in the direction 4-4 of Fig. 1 and illustrating the vane substrate, an existing protective coating applied to the substrate and a typical diffusion cooling hole extending through the substrate and the coating;

[0029] Referring to Fig. 4, a cross-sectional view of the wall thickness of the airfoil 12, and in particular the diffusion hole 18, is shown taken along the line 4-4 of

[0030] To further protect the vane 10 (Fig. 1) from high temperatures, the airfoil 12 and the platforms 8, 14 are coated with a protective surface coating, preferably a thermal barrier coating (TBC) system. The thermal barrier coating system 44 comprises a metallic bond coat 46 disposed over a substrate 58 of the vane 10 (Fig. 1), and a ceramic top coat 75 on top of the bond coat 46.

[0048] Referring now to Figs. 1, 4 and 5, diffusion holes 18 located in region 50 may require reworking. The application of the nonoriginal metallic bond coat 46 to the entire surface 78 of the vane 10 may result in a quantity of excess bond coating accumulating in the diffusion passage 52 of the diffusion holes 18 thus reducing the area through which the cooling air passes. Since this "coatdown" phenomena, as shown in Figs. 4 and 5, affects most, if not all of the diffusion holes 18 in region 50, the effectiveness of the cooling medium is diminished and the vane's durability is compromised. The coatdown phenomenon is normally not a problem during the manufacture of original equipment vanes since the protective coatings, and in particular, the metallic bond coat, are usually applied prior to installation of the cooling holes.

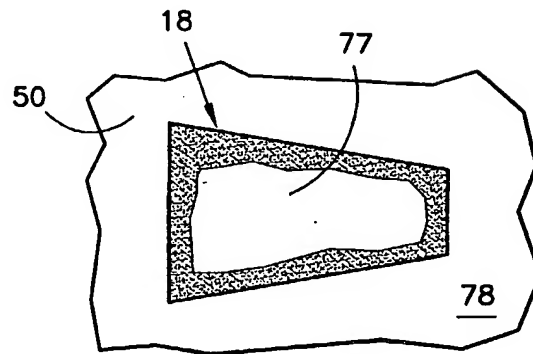
FIG.5

Fig. 5 is a view taken essentially in the direction 5-5 of Fig. 4 showing the diffusion hole prior to the repair of the present invention;

Fig. 1. Fig. 5 shows a view taken essentially in the direction 5-5 of Fig. 4 showing the diffusion hole 18 prior to the repair of the present invention.

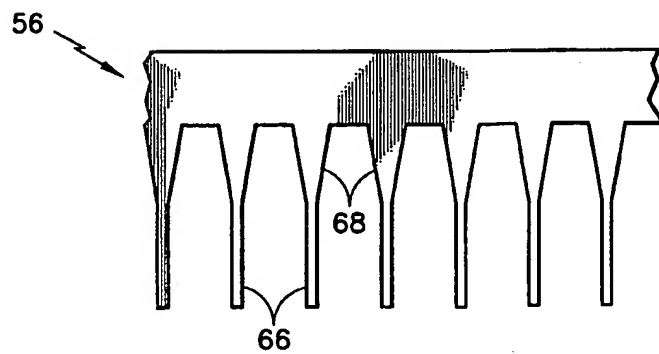
FIG.6

Fig. 6 is a side view of an electrode suitable for use with the repair method of the present invention; and

Fig. 7 is a side view of an electrode suitable for use with the repair method of the present invention.

[0052] The electrode 56 includes a metering portion 66 and a diffuser portion 68. The electrode 62 includes a diffuser portion 70. It is noted that the geometry of the individual electrodes 56, 62, specifically the respective portions 66, 68, 70, are preselected to correspond to the required shape of the corresponding diffusion hole 18 to which it is used. In particular, the electrode 56 is chosen to restore the inner diffuser portion 80 and inner me-

[0051] Referring to Figs. 6 and 7, electrodes 56, 62 suitable for insertion into an electric discharge machining device are shown. Referring to Figs. 1, 4, 5 and 6, the remanufacture and repair of the diffusion holes 18 in local regions 48, 50 of vane 10 using electrodes 56, 62, respectively, will now be described.

tering portion 82 of the respective diffusion hole 18 being repaired in region 48. Similarly, the electrode 62 is chosen to restore the inner diffuser portion 80 of the respective diffusion hole 18 being repaired in region 50. This ensures that after the repair is done, the predetermined air flow requirements of the respective diffusion holes 18 are met.

[0054] In local region 48, the diffusion hole 18 is now remanufactured using the electrode 56. Since the repair material filled the diffusion hole 18, both the metering portion 66 and diffuser portion 68 of the electrode 56 are required to effect the remanufacture. The diffuser portion 68 of the electrode 56 corresponds in shape to the diffuser passage 52, and more specifically, the inner diffuser portion 80, of the diffusion hole 18. While, the metering portion 66 of the electrode 56 corresponds to the metering passage 60, and more specifically, the inner metering portion 82 of the diffusion hole 18.

[0055] However, in local region 50, the diffusion holes 18 may be partially or fully clogged, as described earlier, and therefore will need to be reworked to restore the cooling effectiveness of the diffusion hole 18 as well as vane durability. This is accomplished by using the electrode 62 to remove the excessive bond coat material. The electrode 62 may be easily formed by removing a metering portion from an electrode that has a diffuser portion corresponding in shape to the diffuser passage 52, and more specifically, the inner diffuser portion 80, of the diffusion hole 18. This can be accomplished by using a cutting means, for example scissors, to remove the metering portion.
